Report No.
SSRP – 2000/16
FINAL

**SEISMIC RESPONSE OF INTEGRAL
BRIDGE CONNECTIONS**

Final Research Report funded under Caltrans Contract Number
59A0051

June 2001

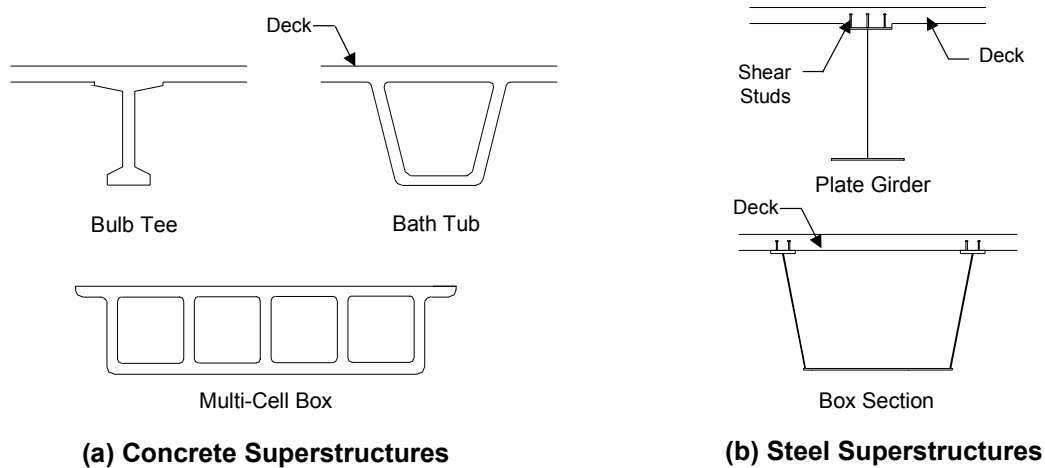
Figure 1-2 Bridge Superstructure Configurations

Steel plate girders or box sections (Figure 1-2b) can also function as longitudinal girders of the superstructure and can be made composite with a concrete deck with shear studs. The high strength-to-weight ratio of steel reduces the superstructure weight and increases the distance that can be spanned. Because steel girder fabrication is done at a mill, the girders are delivered to the site already constructed and ready to be set in place, eliminating the need for formwork and associated construction hazards that may necessitate road closures or traffic interruptions.

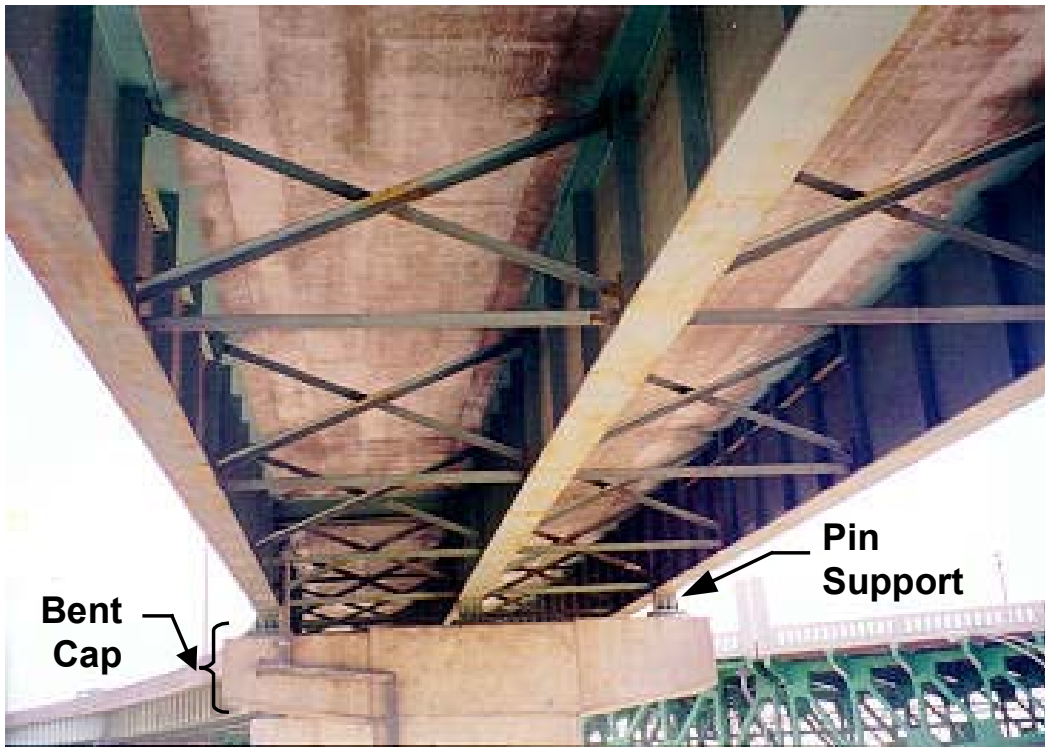
Figure 1-6 Steel Superstructure on Concrete Hammerhead Bent Cap (4)

When a steel superstructure bridge with a concrete substructure is constructed in California (Figure 1-1 and Figure 1-6), the superstructure is typically connected to the substructure by a pin or rocker bearing, a connection which requires high maintenance to protect the pin component against rust. Unlike the monolithic concrete super-to-substructure connections, this steel superstructure to concrete substructure pin connection detail allows relative rotation between the superstructure and substructure.

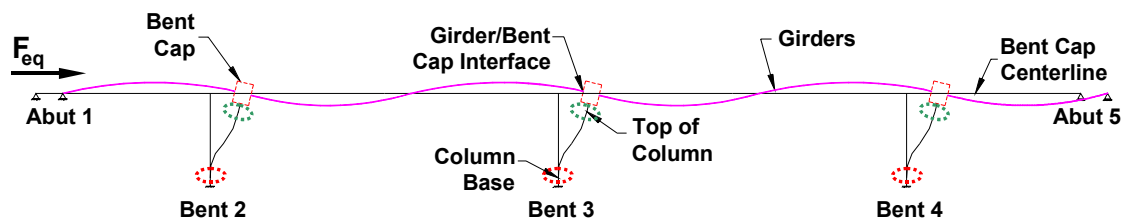
Figure 1-9 Potential Hinge Locations

To ensure that the inelastic mechanism occurs in the desired location (the column), adjacent members, where inelastic actions are not desired, must be designed to ensure elastic response. All locations susceptible to inelastic action are identified in Figure 1-9, on the deformed shape of a bridge model subjected to a longitudinal seismic motion. The desired failure mechanism locations are highlighted by dashed ovals at the top and bottom of each column. At these locations, the column is detailed to ensure flexural ductility. At each pier, the bent cap, the girders, and the interface between the bent cap and girders must perform elastically. These members are considered capacity protected components and need to be designed using the full column overstrength moment based on capacity design principles.

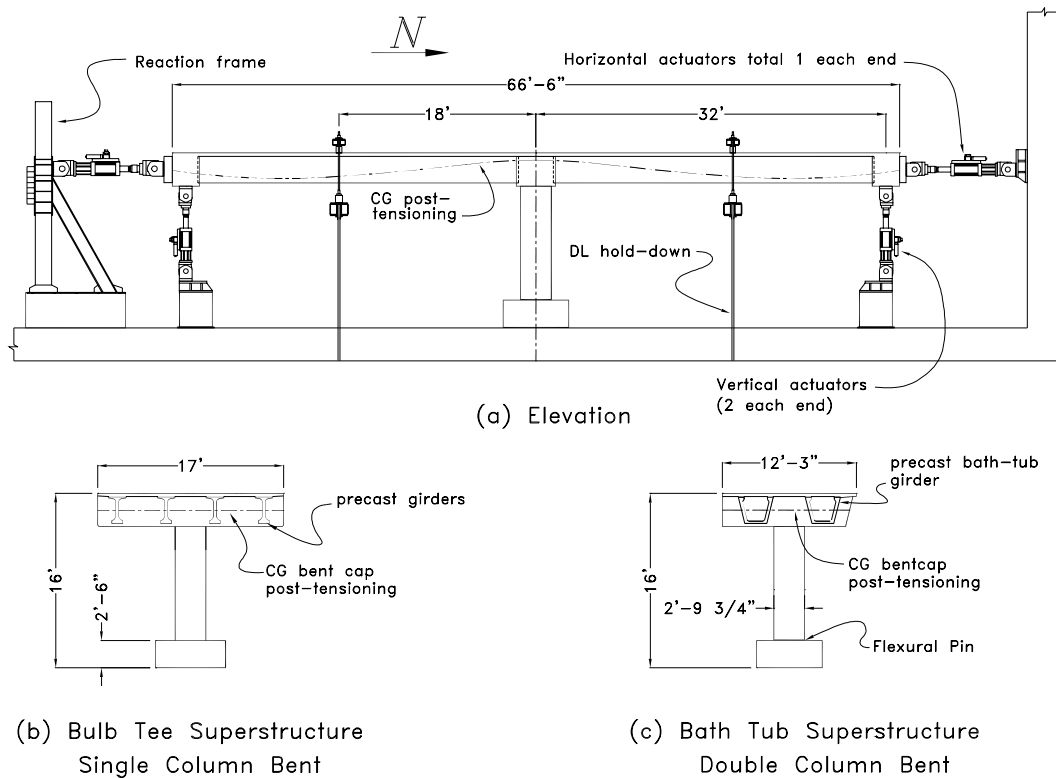
Figure 1-10 Precast Superstructure Configurations (9)

the viability of such connections under a longitudinal seismic event. A similar issue arises with precast girder/concrete composite superstructures integral with concrete substructures. Holombo, et al. (9, 10) investigated the use of precast concrete girders integrally connected to a CIP concrete substructure through a research program that included two large-scale tests (Figure 1-10a). The girders of the first test were precast bulb tee girders that ran continuously through the bent cap, integrating the cap into the superstructure (Figure 1-10b). The second test had precast bathtub girders, which terminated a distance inside the bent cap (Figure 1-10c). In both tests, the girders were supported while the bent cap was cast around them.

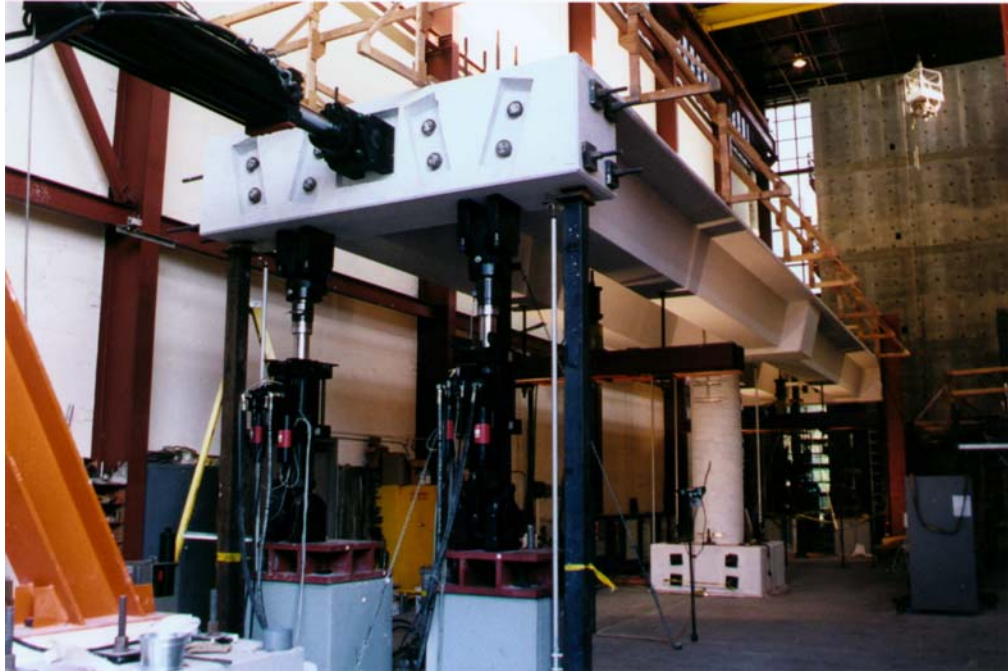
Figure 1-11 Precast Bathtub Girder Test (9)

The two tests, constructed at 40% scale were subjected to a simulated longitudinal seismic event (Figure 1-11). Both tests performed well and demonstrated that a reliable connection could be developed between precast superstructure girders and the cast-in-place concrete bent cap, forcing hinging into the column with minimal superstructure damage.

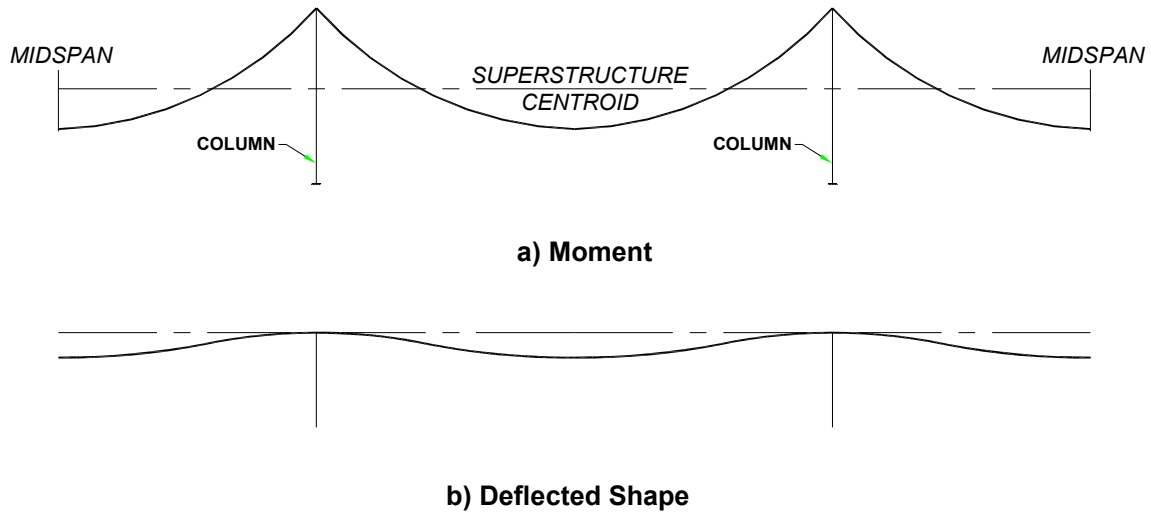
Figure 2-5 Prototype Superstructure Moment and Deflected Shape Due to Self-Weight

Since the superstructure was continuous, it was in positive bending at midspan and negative bending over the piers (Figure 2-5). Therefore, the section over the supports where the concrete deck can be assumed cracked was designed considering only the girders and the deck reinforcing steel contributed to the flexural capacity while flexural capacity of the midspan section included the contribution from the deck concrete. Using influence lines, the maximum live load demands on the girder were determined and the section was designed for the load cases specified in Caltrans Bridge Design Specifications (BDS) (14).

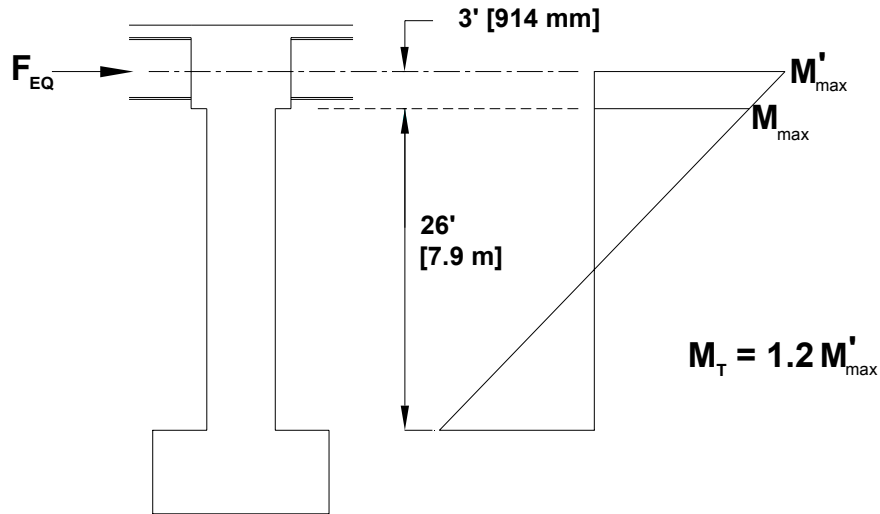
Figure 2-6 Substructure Seismic Moment

The moment at the top of the column due to full material overstrengths, M_{max} , (Figure 2-2) was extrapolated to the center of the girder section (Figure 2-6). This extrapolated moment, M'_{max} , is the moment expected to be transferred through the bent cap to the girders via equilibrium torsion. To ensure the superstructure elastically transfers the moment M'_{max} , it is multiplied by an overstrength factor of 1.2, a component overstrength factor designated in the Caltrans Seismic Design Criteria (20). This results in a column overstrength moment at bent cap centerline M_T .

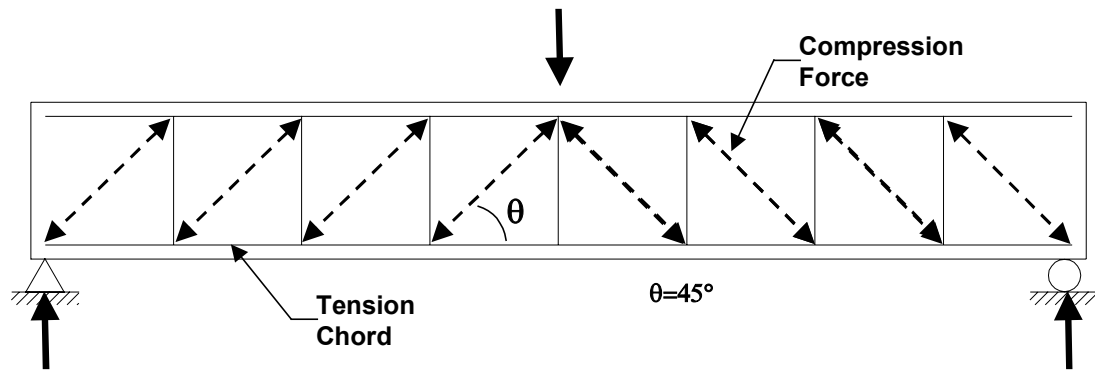
Figure 2-16 Beam Shear Represented as a Plane Truss

Around the same time, Ritter, in 1899 (30) introduced the concept of using a truss model to explain load paths in cracked reinforced concrete members (Figure 2-16). He explained the transfer of shear in a beam as a series of diagonal compression forces balanced by horizontal and vertical tension forces. In his model, the concrete compression stresses were assumed to act at 45° angles while the stirrups and flexural reinforcement made up the vertical and horizontal members of the truss. The inclination of compression members corresponds to the inclination of crack patterns. Morsch (31) in 1902 expanded on Ritter's truss analogy by suggesting the compression force was more akin to a continuous compression field rather than discrete struts. In both Ritter and Morsch's models, the contribution of tensile stress in the concrete is neglected as is the dowel action of reinforcement.

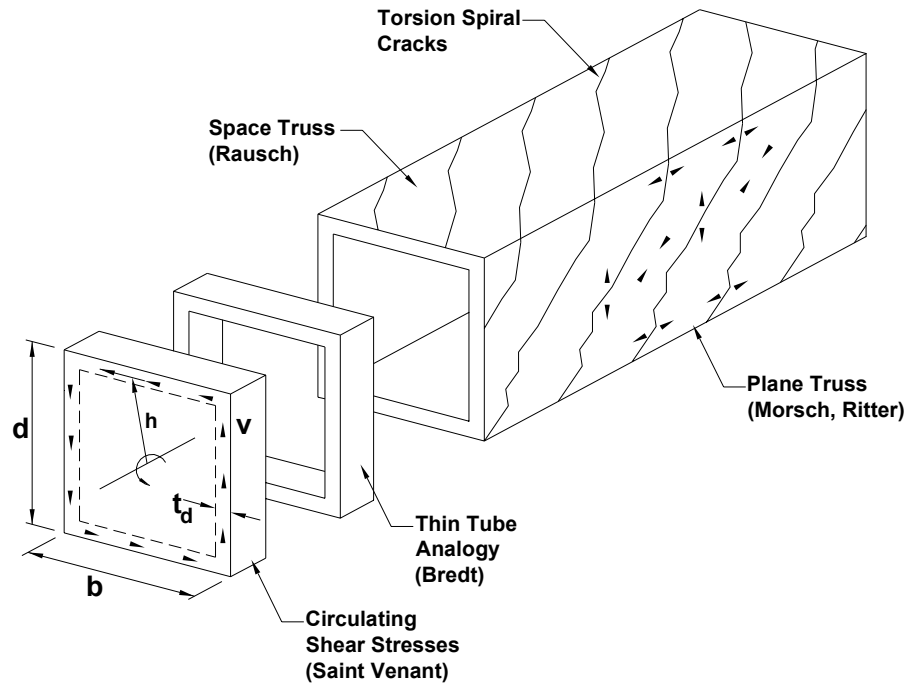
Figure 2-17 Development of Space Truss Analogy (adapted from (27))

All the previously described scientific developments before 1929 were combined in Rausch’s Ph.D. thesis (34) to develop a space truss model to describe a section in torsion. The space truss uses Saint Venant’s circulating shear stresses and Bredt’s thin tube. Rausch then uses four plane trusses as described by Morsch to make up the walls of the tube. This leads to a three-dimensional explanation of the post-cracking behavior of a section in torsion.

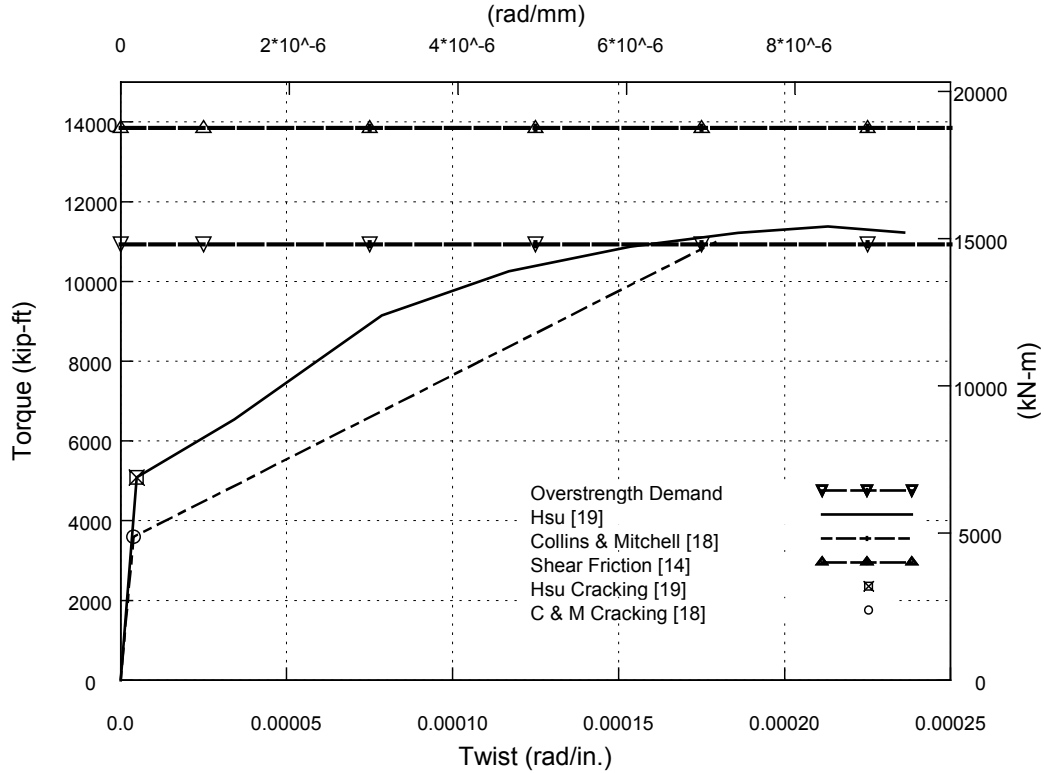
Figure 2-19 Prototype Torque – Twist Prediction

This cracking torque and twist according to Collins and Mitchell is plotted with a circle in Figure 2-19.

This section presented two procedures for developing torque-twist curves for the prototype bridge. The procedures are based on the assumption that the section is of sufficient length for a full helical failure surface to develop. The torsion shear friction analysis presented in the next section predicts ultimate force capacity for short sections that fail in a vertical shear friction plane.

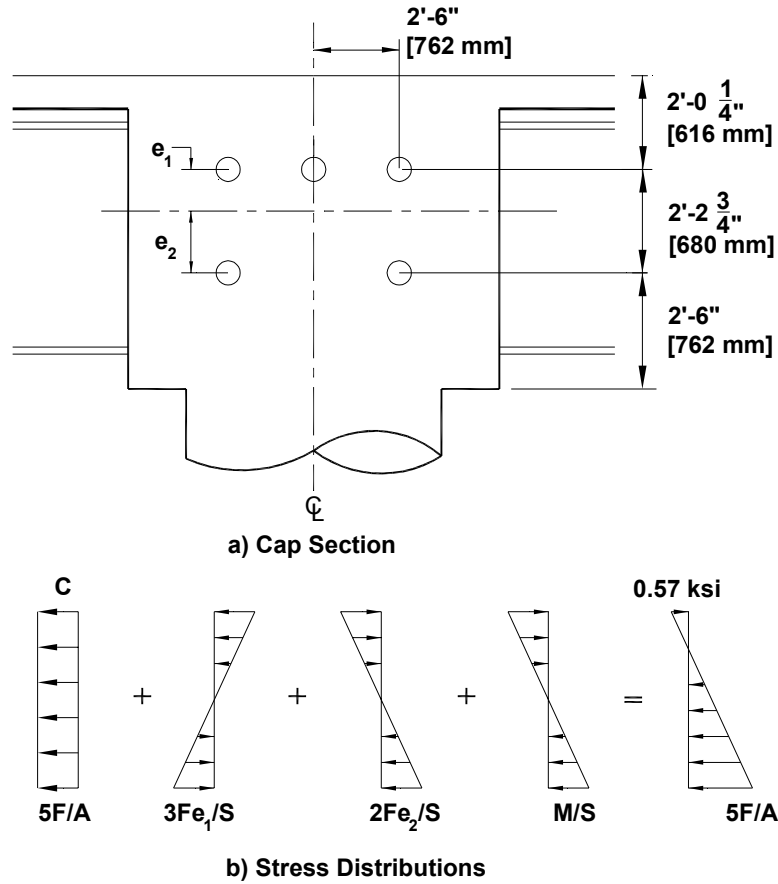
Figure 2-21 Post Tensioning Layout

The post-tensioning layout and stress distributions are shown in Figure 2-21. The post-tensioning was continuous, passing through precut holes in the girders. Again, the shear capacity decrease due to the holes is not an issue as the girder in that region was essentially continually braced as a result of being cast in the cap. The required post-tensioning value is determined by imposing the moments due to live loads and dead loads as determined in Section 2.6.1 and limiting the concrete tensile stress to 0.57 ksi [4 MPa] and the compressive strength to 4 ksi [28 MPa]. The post-tensioning force, F , is the same in all five rods, e_1 and e_2 are the post-tension eccentricity from the section centroid of the top and bottom post-tensioning, respectively, and S is the bent cap section modulus.

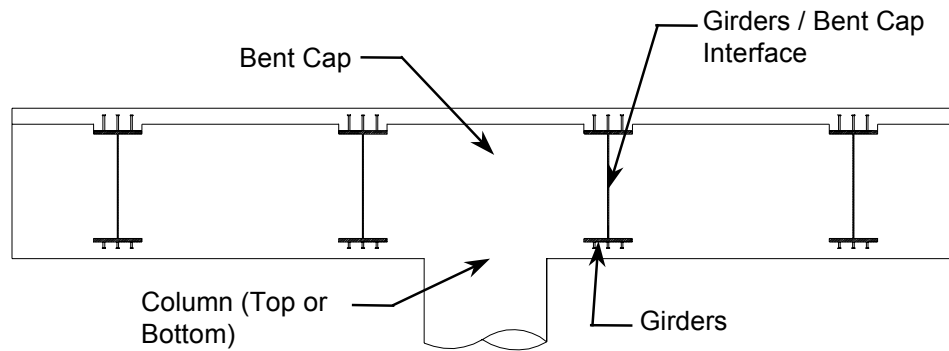
Figure 2-22 Potential Failure Mechanisms Locations

As stated in Section 1.2, all undesirable inelastic actions need to be prevented to ensure the desired failure mechanism occurs in the column. Section 2.6.2 outlined how the bent cap is designed to prevent a torsion failure. The girders are designed to prevent a flexural failure by accounting for the additional moment demand imposed from a seismic event. The final component to be designed using capacity protection principles is the interface of the steel girder and the bent cap (Figure 2-22).

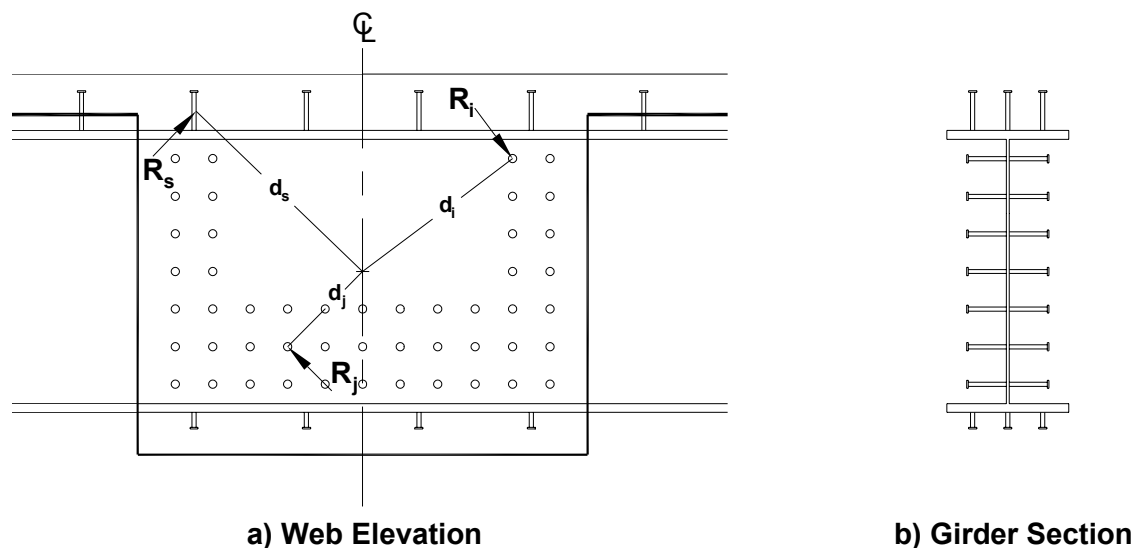
Figure 2-25 Stud Group on Girder Web

the reaction force on each shear stud is determined. A total of 90 studs were distributed on the girder web as shown in Figure 2-25a. Applying the concept of eccentrically loaded connections to this shear stud distribution on the girder web, the stud group was expected to carry 6,000 k-ft [8,130 kN-m] of the 9,000 k-ft [12,195 kN-m] demand.

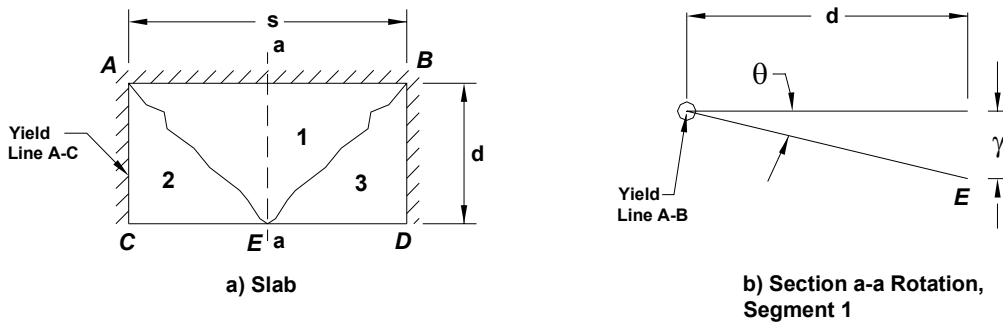
Figure 2-26 Yield Line Theory for Concrete Slabs (adapted from 45)

In Figure 2-26a, yield lines are assumed for a uniformly loaded concrete slab fixed on three edges and free on one edge. The five yield lines (two diagonals across the section and one along each fixed edge) serve as axes of rotation for the three sections they divide the slab into. The ultimate load this slab can carry is determined using the yield lines and the principle of virtual work. The principle of virtual work states that the sum of all work done on a system in equilibrium is zero. Therefore, the work due to the external force to apply the displacement γ is equal to the work due to internal actions along the yield lines that resist it.

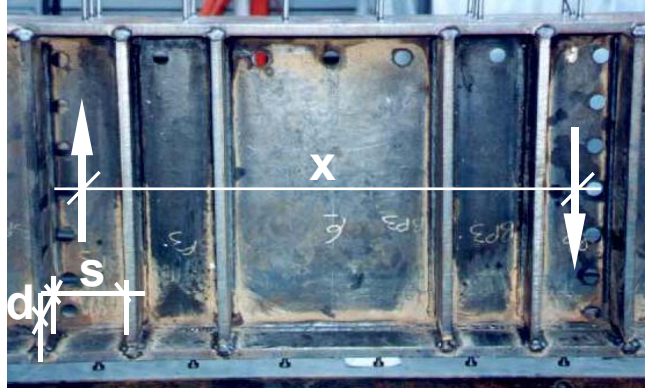
Figure 2-28 Torsional Capacity of Concrete Compression Struts

Once the stiffener spacing is found to maximize the compression strut, the force from the strut is found by multiplying the concrete compressive strength by the area of flange the strut acts over. This gives a resultant force oriented as shown in Figure 2-28, which is multiplied by the moment arm to obtain an approximation for the moment transferred by the concrete struts. With the spacing determined from this analysis, the resultant moment transferred in the two outermost struts is 5,040 k-ft [6,829 kN-m] of the 9,000 k-ft [12,195 kN-m] moment demand.

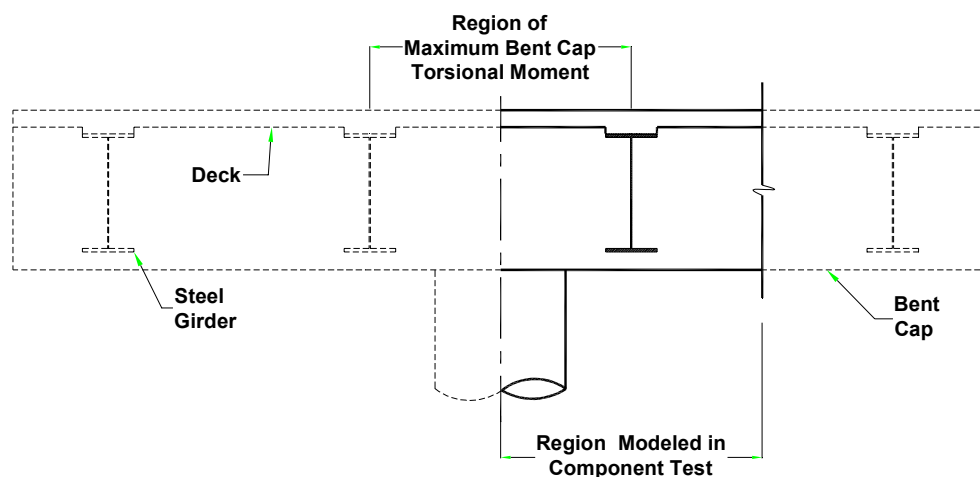
Figure 3-1 Component Test Region of Investigation

Due to symmetry of the prototype structure about Pier 3 (see Figure 2-1), all tests are designed for Pier 3. As shown in Figure 2-8, the maximum bent cap torsional moment occurs at the column centerline and is equally distributed to the superstructure on either side of the column. Hence, the portion of superstructure between the column centerline and the interior girders is the critical location (Figure 3-1). In order to capture the highest torsional moment demand on the bent cap, it is only necessary to model the superstructure between the column centerline and either interior girder.

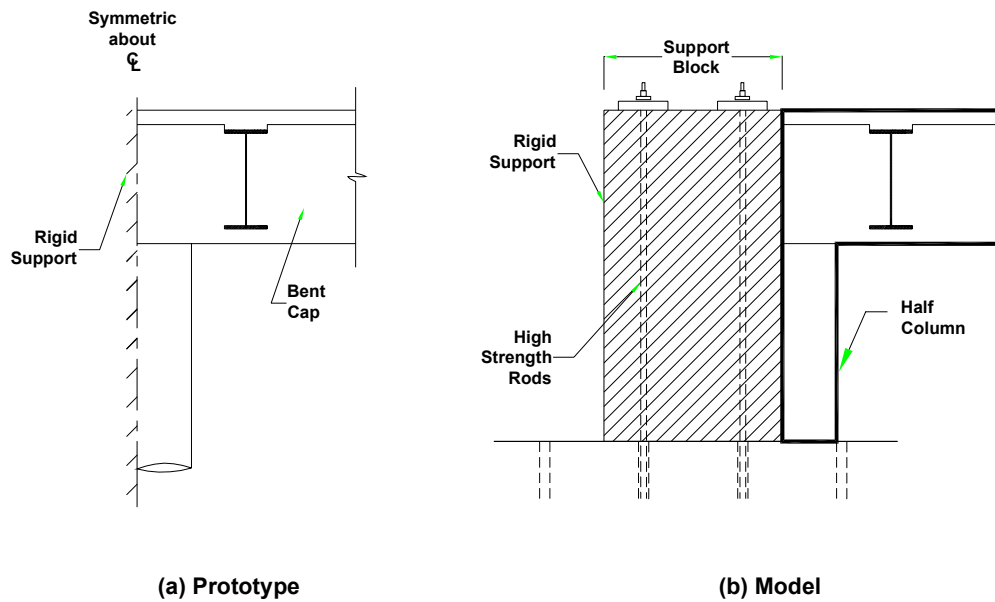
Figure 3-2 Component Test Specimen Prototype and Model

To protect against premature column failure, the bridge section shown in Figure 3-2a is supported by a rigid concrete block (Figure 3-2b). The block is post-tensioned to the laboratory floor with 1- $\frac{3}{8}$ " [35 mm] diameter Grade 150 [1,034 MPa] high strength rods. A partial column with vertical and spiral reinforcement was designed to protrude from the support block.

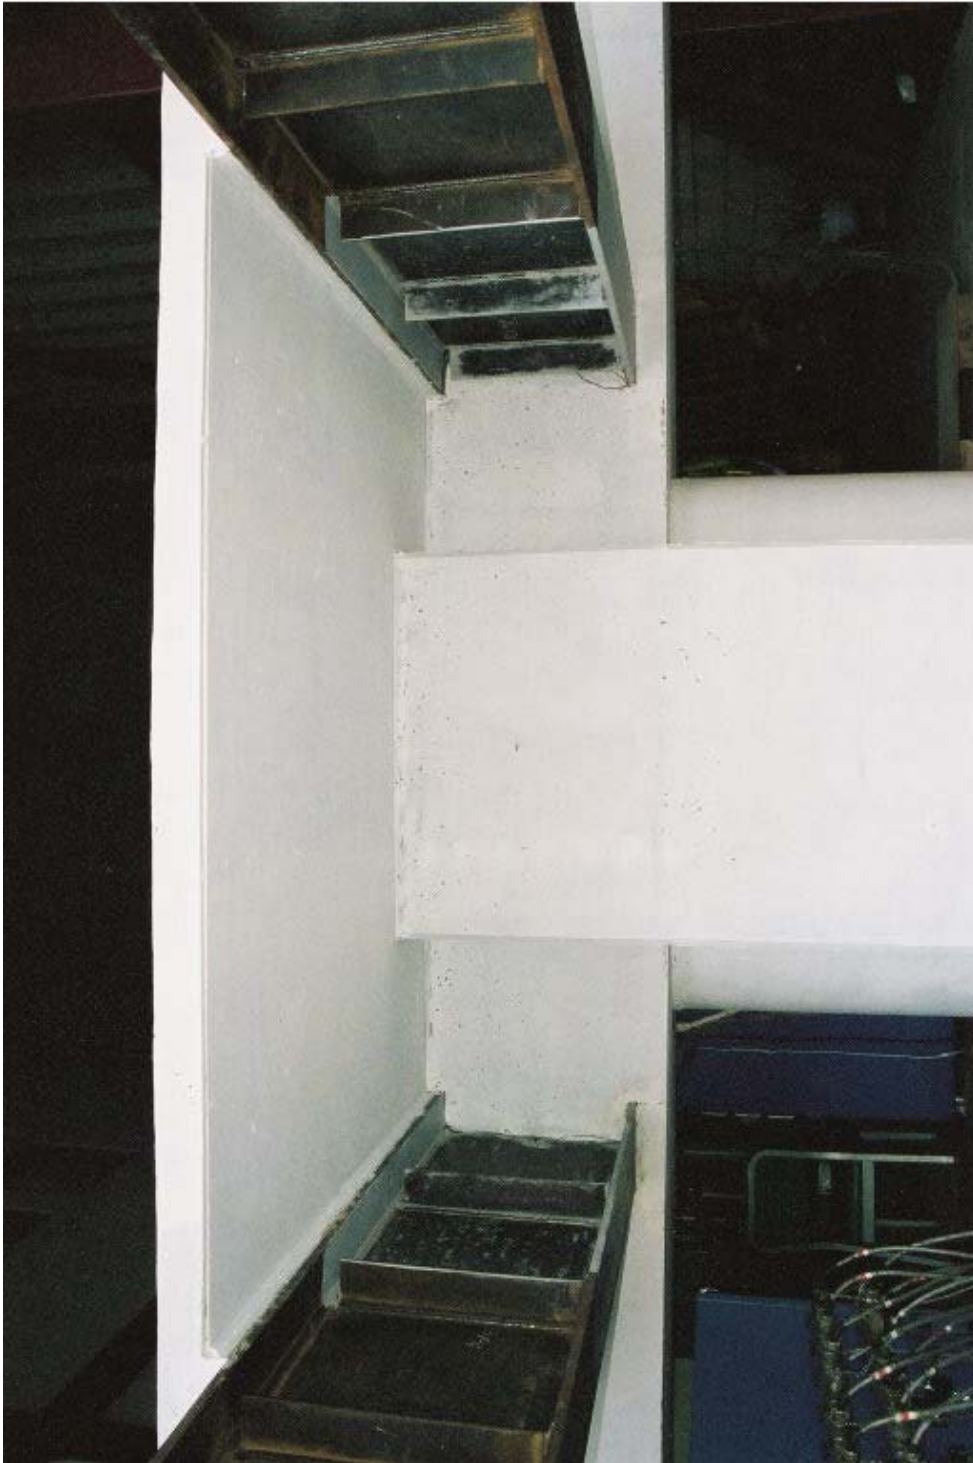
Figure 3-5 Component Test Specimen Before Testing

the correct stresses. A three-dimensional rendering of the setup is presented in Figure 3-4 and the setup as it was prior to instrumentation and testing is shown in Figure 3-5.

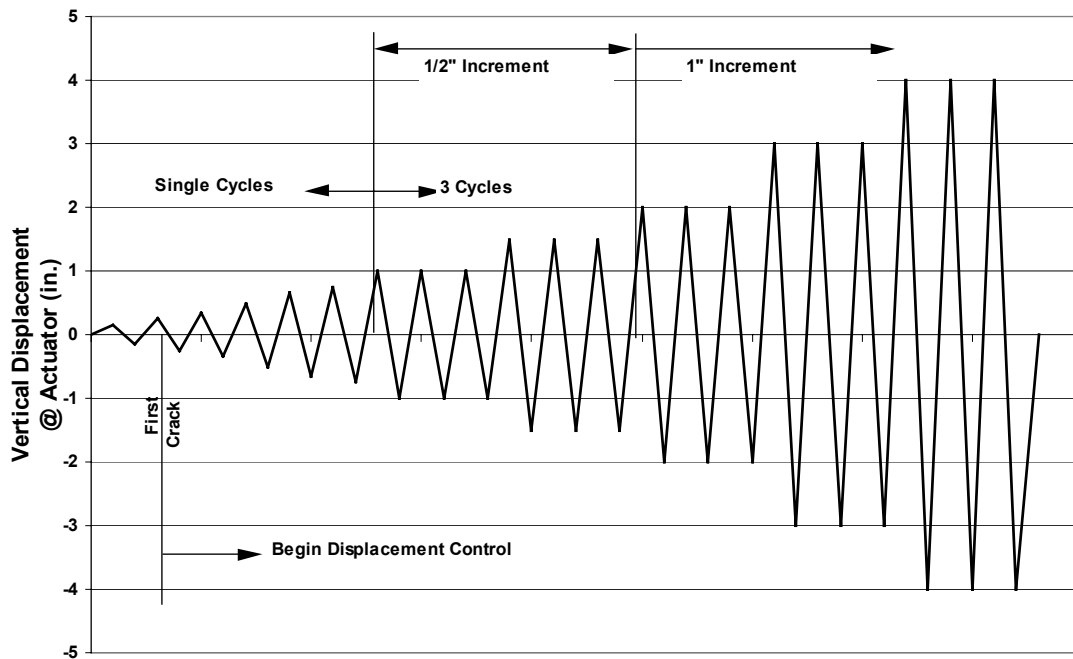
Figure 3-20 Component Test Loading Sequence

applied, the seismic loading protocol began. Seismic loading began in pseudo force control (displacement control while monitoring the force) in single cycles of 5 kip [22 kN] increments to first torsional cracking. After the first crack, the specimen was loaded in single cycle displacement increments of 0.25 in. [6 mm] to 1 in. [25.4 mm]. The specimen was then subjected to three cycles of 0.5 in. [12.7 mm] displacement increments up to 2 in. [51 mm]. After 2 in. [51 mm] displacement was reached, three cycles of 1 in. [25.4 mm] increments were imposed until failure. The loading sequence is detailed in Figure 3-20.

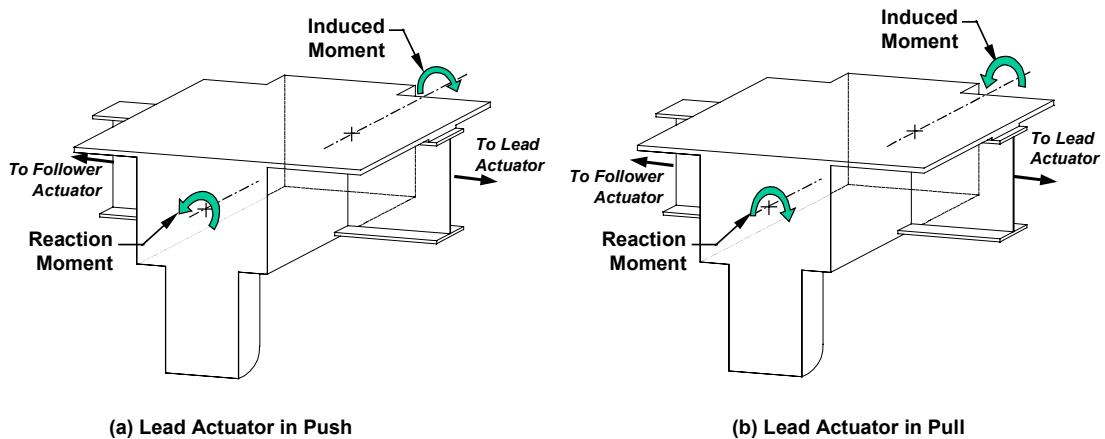
Figure 4-2 Torsional Moment Directions in Component Tests

When the lead actuator is in push, it creates a positive moment about the transverse bridge axis (Figure 4-2a), resulting in the bent cap torsion indicated. This torsional moment in the bent cap is reacted by an opposing moment at the support block. The same equilibrium requirements apply to the lead actuator in pull (Figure 4-2b).

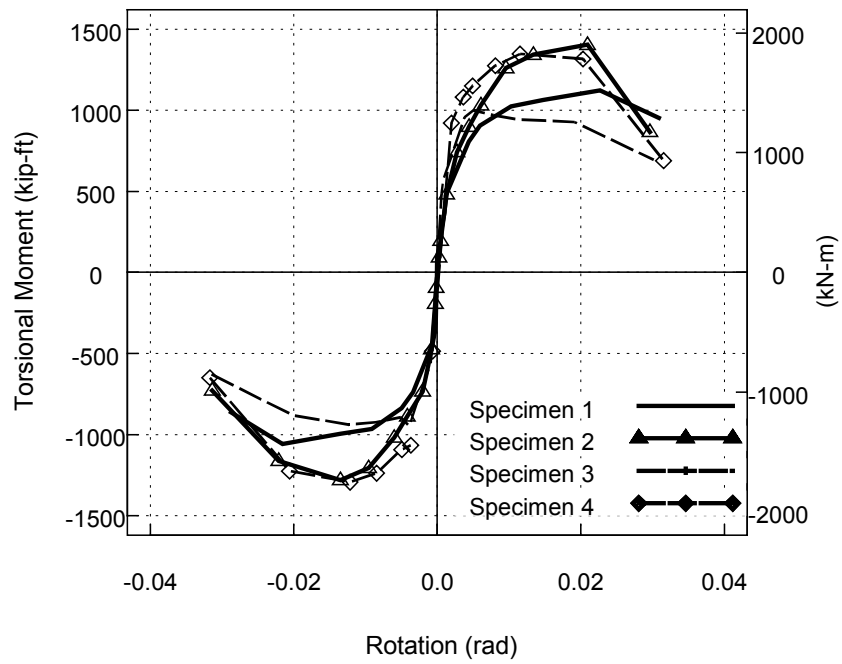
Figure 4-68 Comparison of Torsional Moment-Rotation Envelopes

tensioned bents developed similarly to the conventionally reinforced beam. The remainder of this section presents detailed comparisons between pairs of tests.

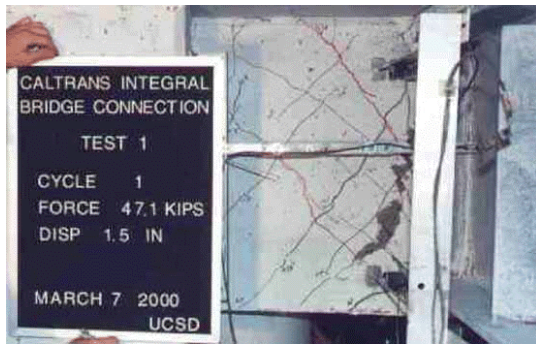
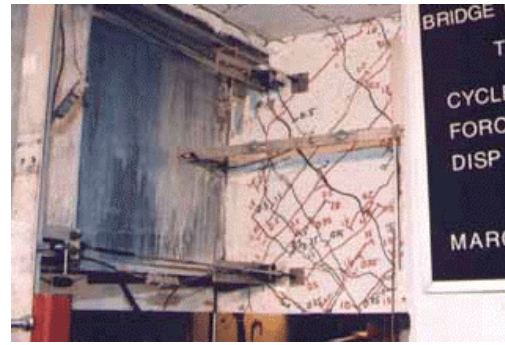
(a) Lead Face

The specimens at their failure load are shown in Figure 4-73. Significant spalling has occurred on the lead face and bent underside in both specimens. The failure mechanism in Specimen CR-NS is a shear-friction failure plane inclined along the initial torsion spiral crack. Deck damage in Specimen CR-NS is limited to cracking. The failure mechanism of Specimen CR-S is a vertical torsion shear-friction failure plane at the edge of the girder flanges. The failure plane propagates through the deck concrete, exposing deck and main flexural reinforcement.

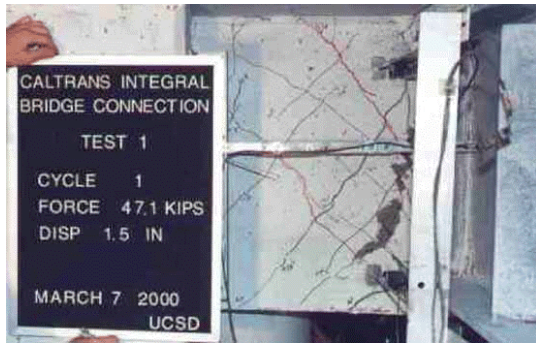
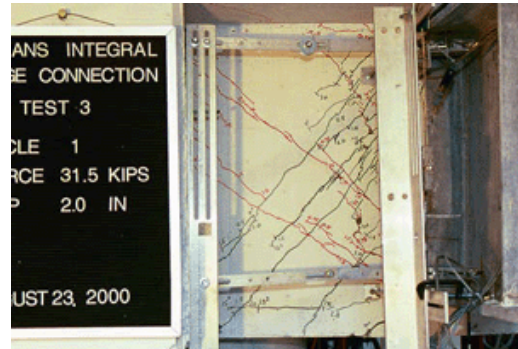
(a) Lead Face

The specimens at their failure load are shown in Figure 4-81. Significant spalling has occurred on the lead and follower faces as well as the bent underside in both specimens. The failure mechanism in both specimens is a shear-friction failure plane inclined along the initial torsion spiral crack. Deck damage in both specimens is limited to cracking.

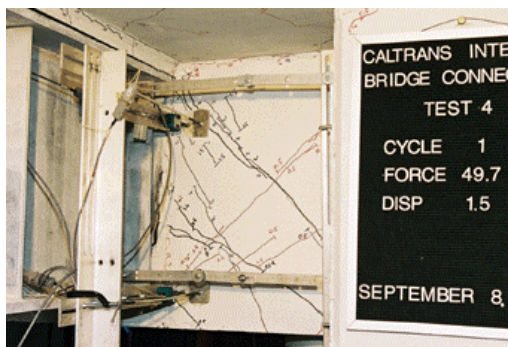
(a) Lead Face

Both specimens are shown at failure in Figure 4-89. Significant portions of concrete have spalled off the lead face of both specimens. Major spalling has also occurred on the underside of both bent caps near the column. In Specimen PT-S, major cracking on the underside of the bent is aligned with the steel girder. The vertical failure plane of Specimen CR-S is apparent from the deck while damage to the deck of Specimen PT-S is limited to cracking.
